**CHARACTERIZATION OF REFORMER TUBE CREEP DAMAGE
BY ULTRASONIC ATTENUATION PATTERN AND
MICROSTRUCTURAL CHANGES**

Dissertation submitted in partial fulfillment of
the requirements for the
Bachelor of Engineering (Hons)
(Mechanical Engineering)

SEPTEMBER 2012

Universiti Teknologi PETRONAS
Bandar Seri Iskandar
31750 Tronoh
Perak Darul Ridzuan

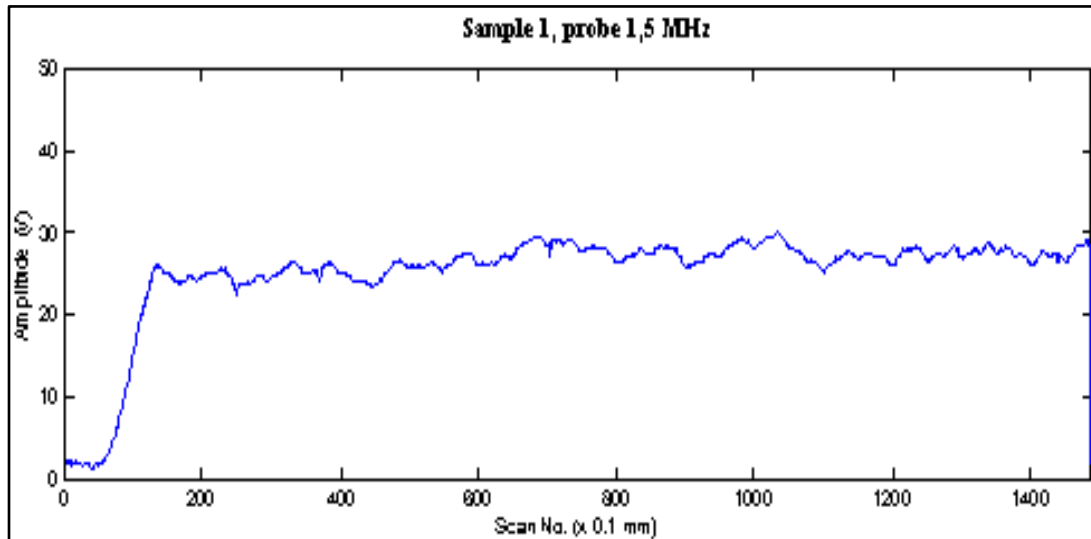
The difference in ultrasonic wave amplitudes acting on different level of creep damage is shown in Figure 2.2 and 2.3 [5].

Figure 2.2: Sample 1, secondary creep voids (low damage degree) [5]

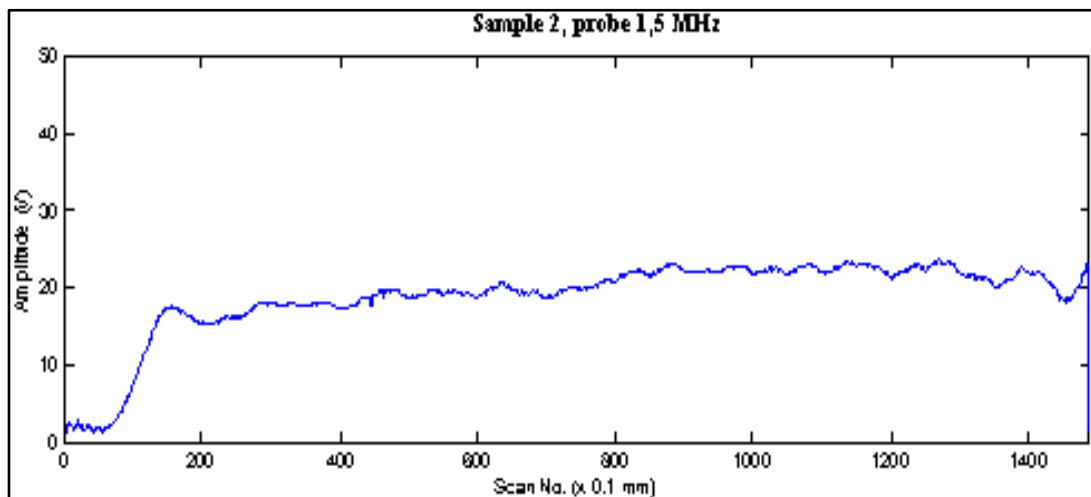
Figure 2.3: Sample 2, secondary creep aligned voids (high damage degree) [5]
