Failure Analysis on the Wire Rope for Lifting Equipment

Dissertation submitted in partial fulfilment of
the requirements for the
Bachelor of Engineering (Hons)
(Mechanical Engineering)

Universiti Teknologi PETRONAS

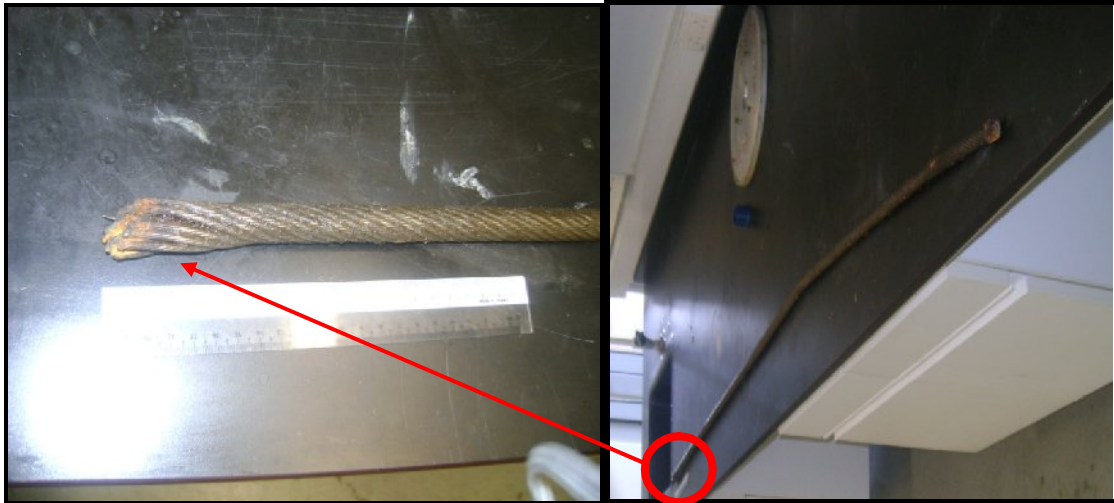
Figure 4.7: Wire rope datum (in the red circle)

The datum for the measurement is the failed part of the wire rope.

Based on the data in Table 4.1, the diameters of the wire rope shows reduction as the diameter measured further from the datum and stay constant in the middle of the wire rope length. This indicated that there is corrosion internally or dislocation of the strand lay of the wire rope.

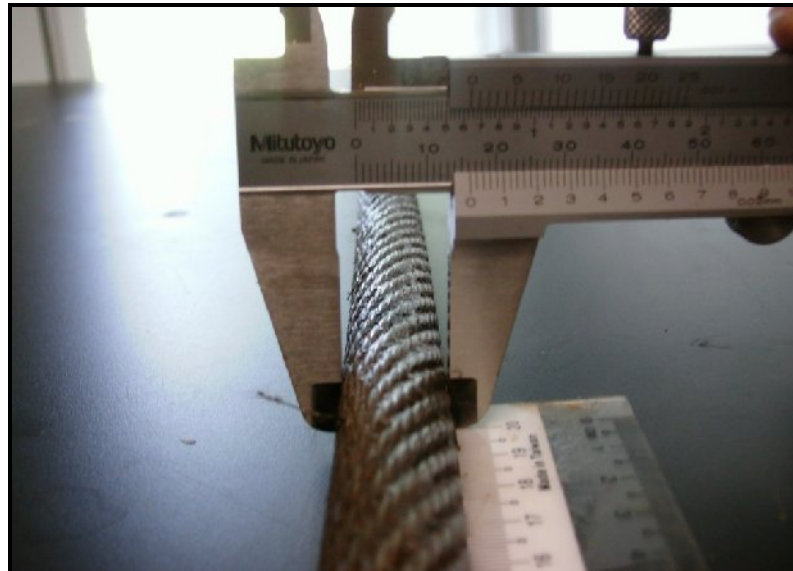
Figure 4.8: Measurement on the wire rope diameter

Length from datum, mm	Diameter measured, mm
0	22.00
200	16.30
400	16.20
600	16.00
800	16.00
1000	16.00
1200	16.00
1400	16.00
1600	16.02
1800	16.03
End (1940)	17.10

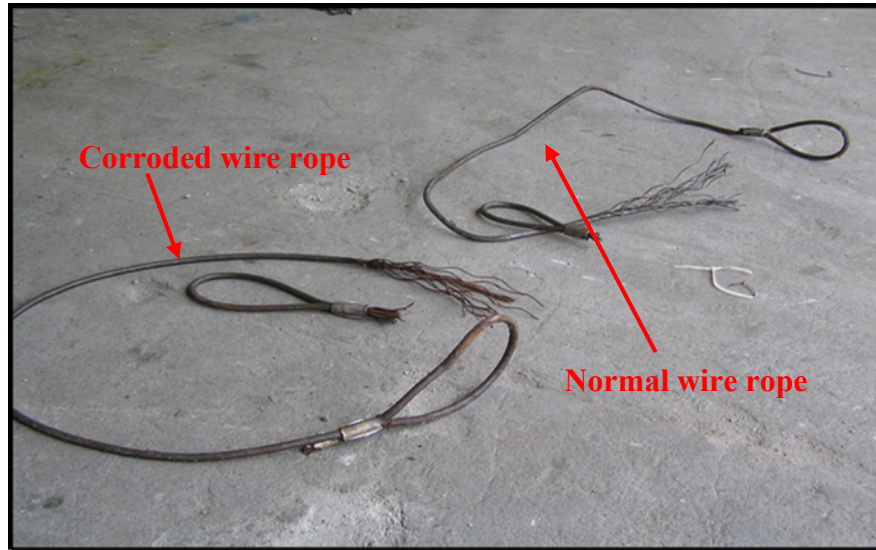
Figure 4.9: Tested specimens

These two wire ropes tested with the pull test bench machine. The maximum of the strength before the wire ropes break at the ferrule recorded. The length of the wire rope are 5ft Comparing the data from the testing to the both the strength of the corroded is much lower.

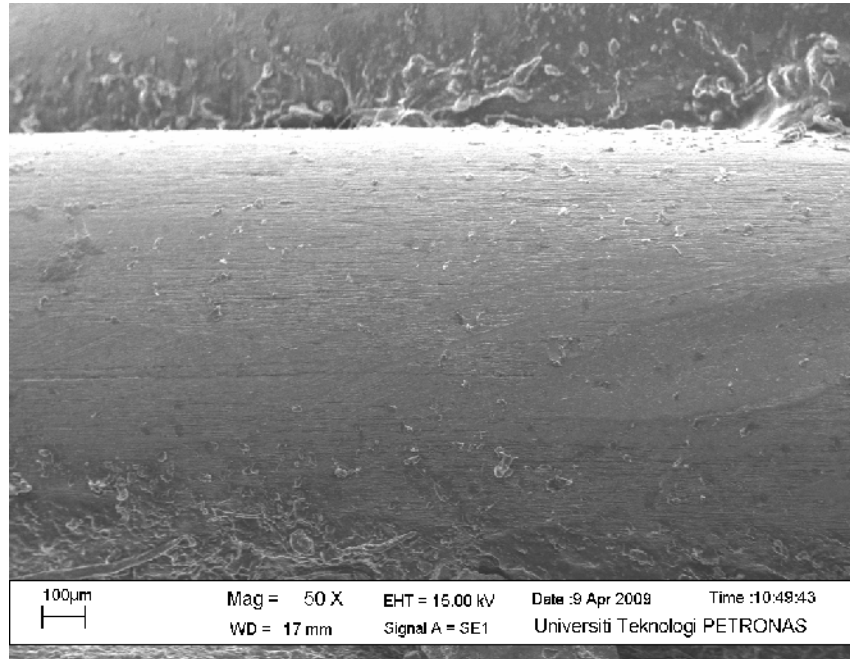
Figure 4.16: Surface magnification 50X using SEM for single wire

The higher magnification view on the surface of normal wire rope show smooth surface. But there is still scratch mark and dent on the surface due to the movement of the strand that will rub each other during manufacturing process. Continuously movement and rubbing process of the wire rope will wear off the surface of the wire rope which protected by zinc coating. As the based metal exposed to the environment without protection the corrosion will occur.

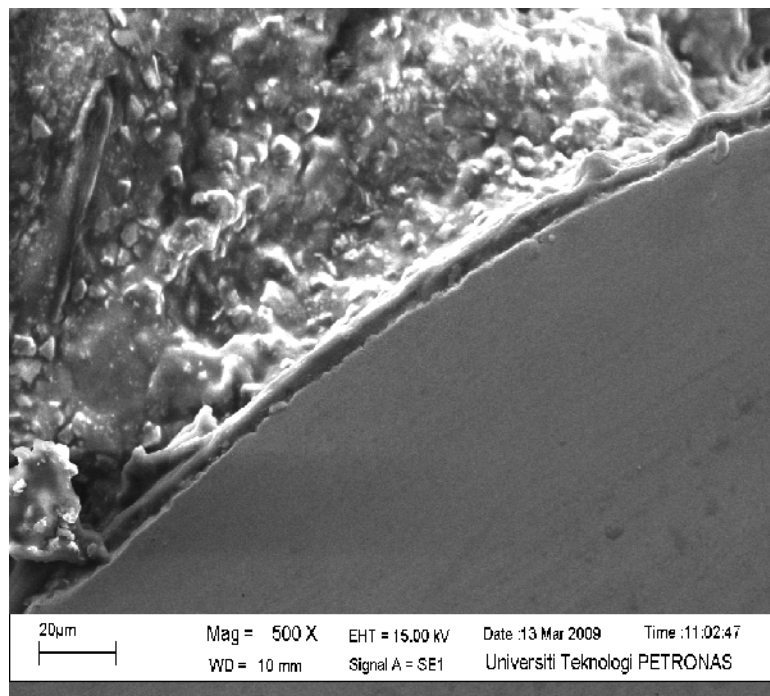
Figure 4.19: Cross sectional of new wire rope at 500X magnification using SEM

For the figure 4.18, the mounted specimen grinded and polished, there is no layer of zinc observed even though the specimen is the new wire rope. This is because there is imperfection of coating process conducted by the manufacturer, the thickness of the coating process for single wire did not measure closely during the manufacturing because API 9A did not state the thickness of the coating it only mention amount of the weight of coating per length of the wire produce, so there is slight possible that at certain part of the wire rope zinc coating is not enough.

After zoom in up to 500X magnification to single new wire as per Figure 4.19, there is still no zinc coatings observed.

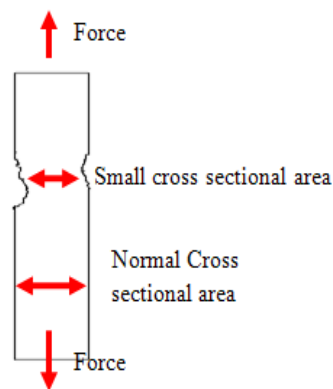
Figure 4.24: Illustration of the effect of cross sectional area

The Figure 4.24 illustrates how the concentration of stress occurs on the small cross sectional area.

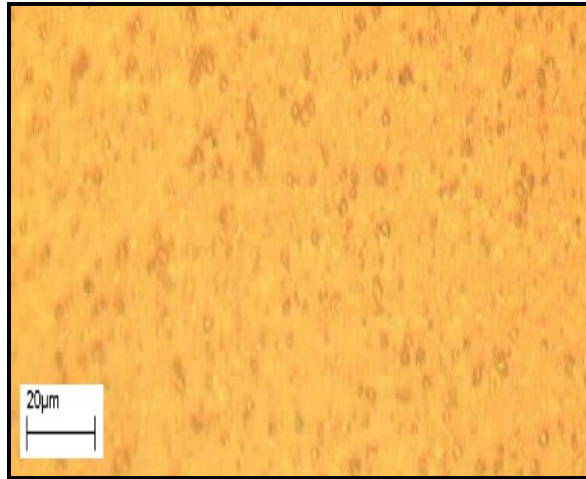
Figure 4.25: Microstructure at 200X using optical microscope

Based on Figure 4.25, the spheroids pattern observed without pores or defect on the wire. Spheroidization is an annealing process used for high carbon steels (Carbon > 0.6%) that will be machined or cold formed subsequently. All these methods result in a structure in which all the Cementite is in the form of small globules (spheroids) dispersed throughout the ferrite matrix. Spheroidization also improves the machinability, making the material soft and more ductile. The wire rope microstructure is acceptable without any stress corrosion cracking or defects.

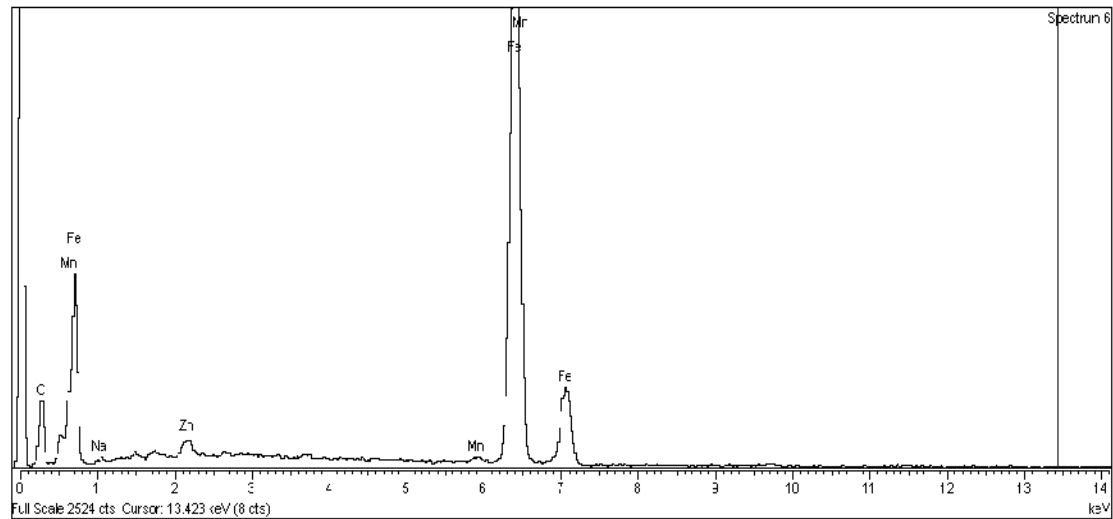
Figure 4.27: EDX on the normal surface

The data obtained for the normal surface is different from the corroded surface whereby there is no zinc oxide and the iron oxide present. As per Figure 4.12, the surface is properly coated and there is no sign of the corrosion.
