**FAILURE ANALYSIS STUDY ON THE CUTTER BLADE OF  
POLYPROPYLENE PELLETER DRIVE**

FINAL REPORT PROJECT

Universiti Teknologi PETRONAS

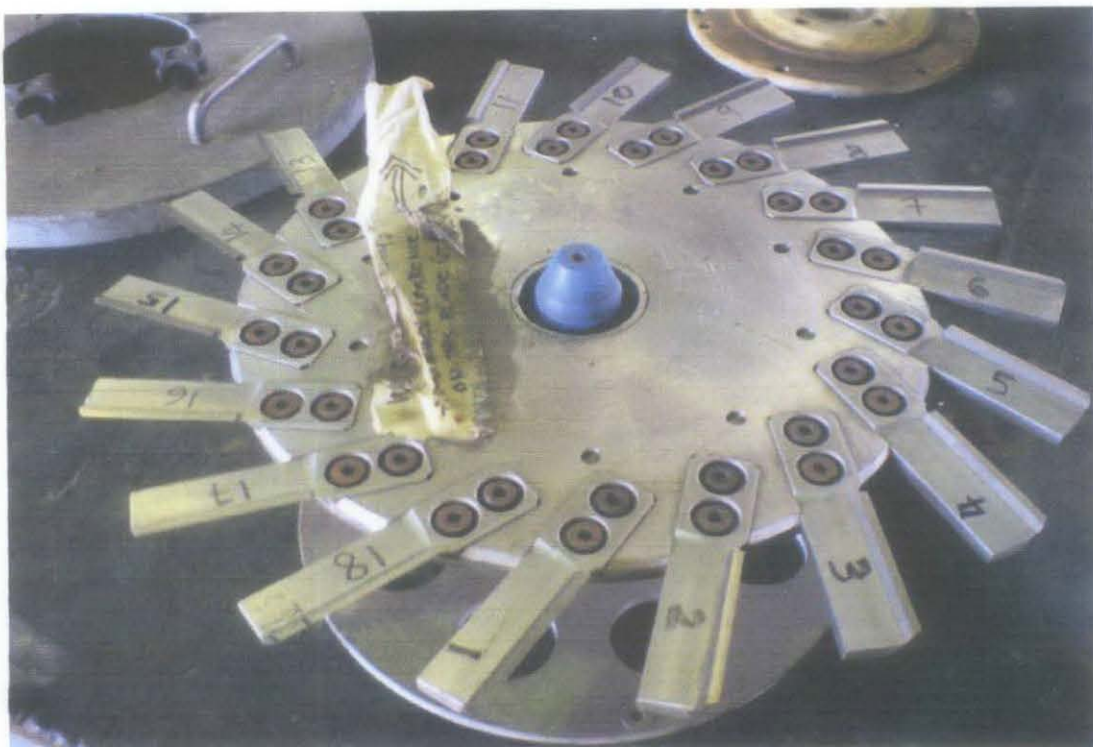
This operating requirement make blades wear unavoidable and the blades are usually scheduled to be replaced every 2 – 3 month or when the allowable wear land reaches maximum of 4 mm. However, in uncertain event the blades chipped off during operation. This is the type of failure which needs attention throughout the study. Figure 13 and 14 shows the cutter blades mounted on its pelleter drive rotor.

Figure 13: New cutter blades mounted on the pelletizer drive.

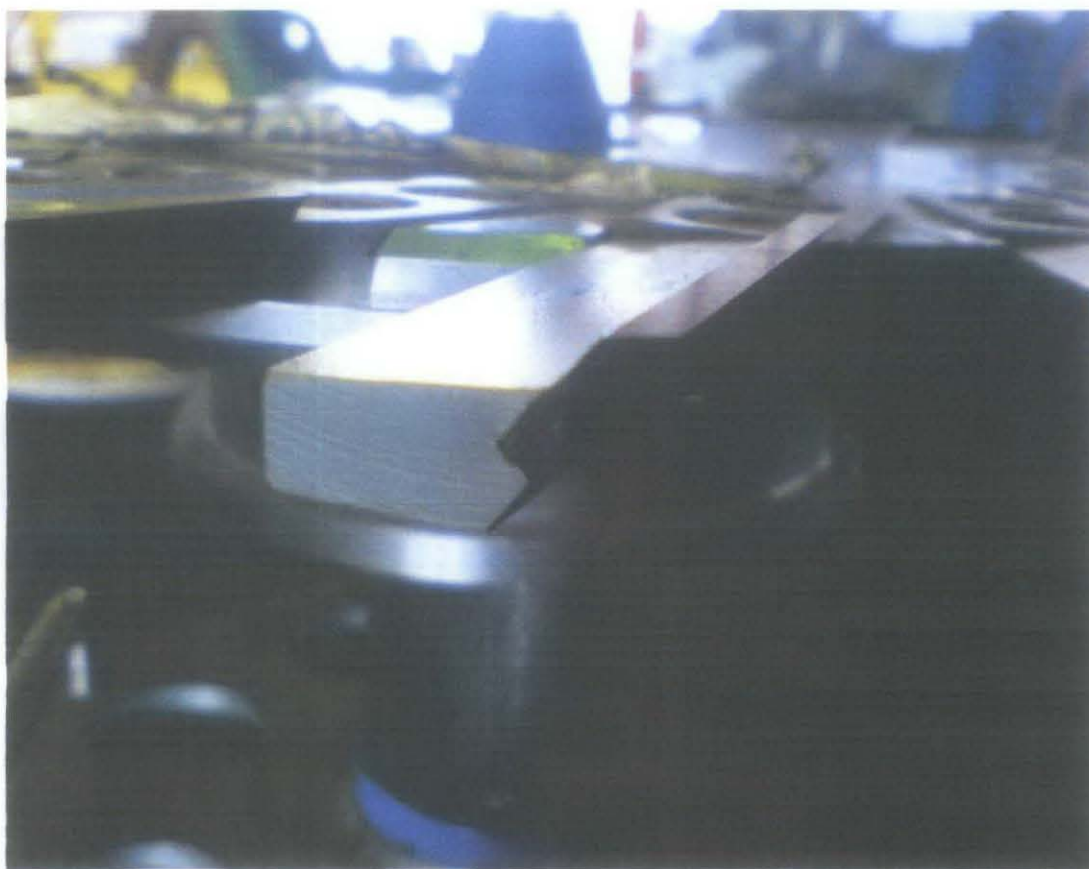
Figure 14: Close-up view of the cutter blade; titanium carbide tip (darker) bonded to stainless steel tip holder (lighter).
