After several years of service, the radiator system of a Kancil car is experienced leaking on its steel pipe. On the early stage of its failure the owner of the car found that the level of radiator coolant has decreased prematurely and the engine temperature increase higher than normal. Regardless of the problem, the owner just filled up the radiator tank with water.

In view of the premature steel pipe failure, it is imperative to investigate the cause of the failure for future action and recommendation.

1. To investigate the cause and the mode of pipe failure.
2. To recommend ways to improve the service life of radiator pipe as well as the radiator system.

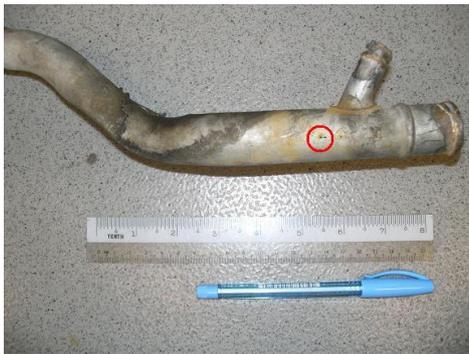
Figure 4.1: The size of the steel pipe

Before any failure analysis and nondestructive examination were preceded, the condition of the sample must be recorded and the pictures of the failure sample are taken as a record. The picture of the external part and internal part were taken. The condition of the steel pipe was capture as shown in Figure 4.1 and 4.2. The location of the leaking area is marked with red circle.
