Gas Turbine Blade Failure Due To Hot Corrosion

Dissertation submitted in partial fulfilment of
the requirements for the
Bachelor of Engineering (Hons)
(Mechanical Engineering)

JANUARY 2008

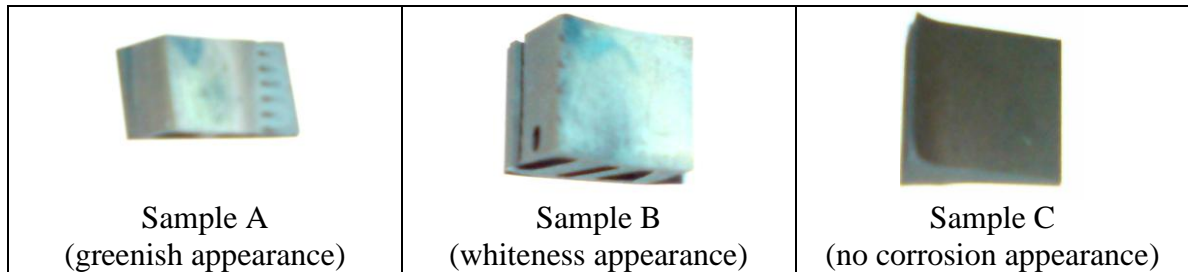
Figure 5: Samples

From the sample of gas turbine blade failure, there are 3 areas that will be named as Sample A, B and C. The machine used to cut the sample from the blade is Electro Discharge Machine (EDM) Wire Cut (see **Figure 7**) in Building 16 room 16-00-05. The picture of the each sample and its location on the blade are as previewed below (**Figure 5 and 6**). Sample A had experienced type I hot corrosion because has greenish appearance. Whereas sample B had been exposed to type II hot corrosion because has whiteness appearance [5]. Sample C is taken from the area with no corrosion appearance. The size for each sample is about 1 cm x 1 cm with small thickness.

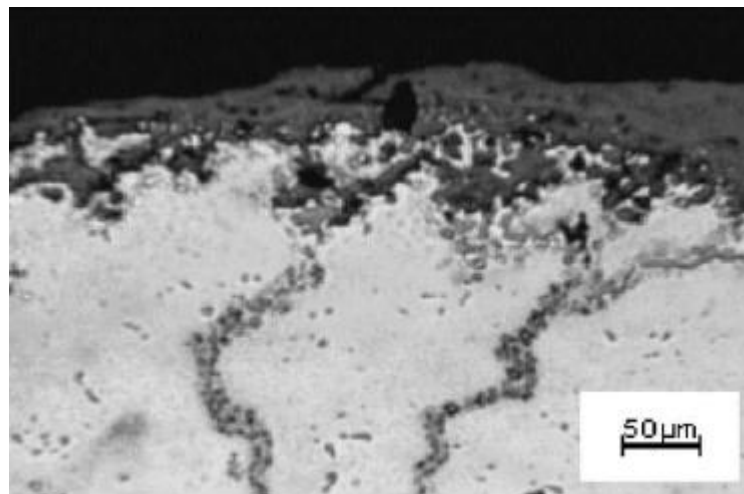
Figure 12: Type I hot corrosion, grain boundary diffusion is seen.

In this experiment, it was expected to capture the picture of grain boundary diffusion on the Sample A and B. If the grain boundary diffusion presented in the sample means that it having type I hot corrosion (**Figure 12**). If not the sample having type II hot corrosion (**Figure 13**).
