**Failure Analysis on Stainless Steel Tubing of a Lube Oil Console for Gas
Generator**

Dissertation submitted in partial fulfillment of
the requirements for the
Bachelor of Engineering (Hons)
(Mechanical Engineering)

JULY 2010

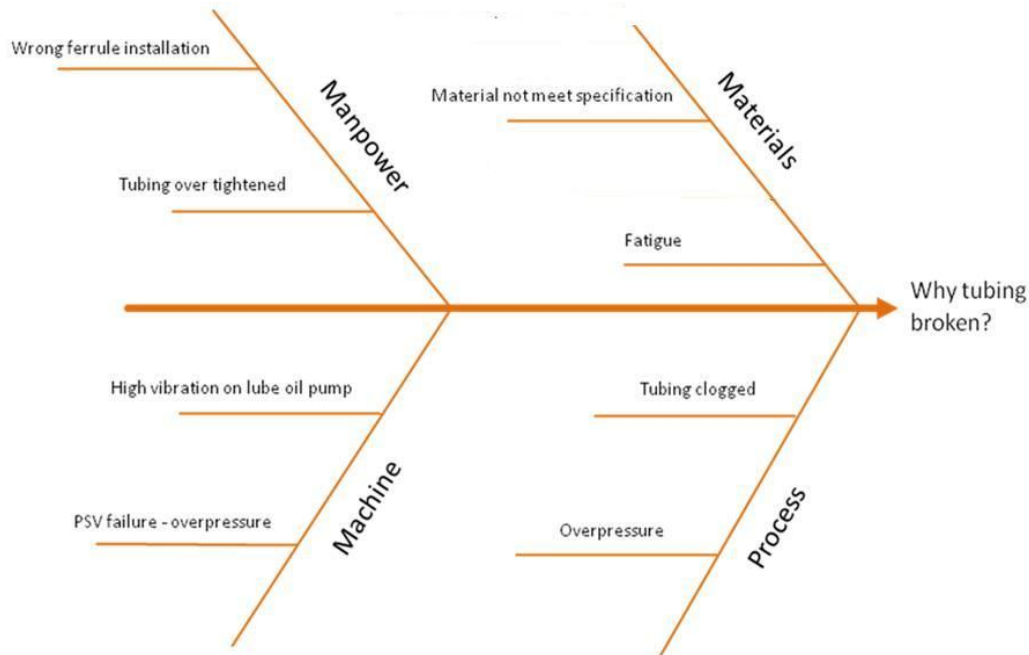
Figure 3.2: Root Cause Analysis (RCA) on stainless steel tubing failure.

Figure 2.1 shows the list of possible root causes using **Root cause analysis (RCA)**. First of all, root cause analysis was done to get the rough idea or assumption of the root cause before the failure analysis started. Root cause analysis is a class of problem solving methods aimed at identifying the root causes of problems or events. The practice of RCA is predicated on the belief that problems are best solved by attempting to correct or eliminate root causes, as opposed to merely addressing the immediately obvious symptoms. By directing corrective measures at root causes, it is hoped that the likelihood of problem recurrence will be minimized. However, it is recognized that complete prevention of recurrence by a single intervention is not always possible. Thus, RCA is often considered to be an iterative process, and is frequently viewed as a tool of continuous improvement. ^[8] In the RCA, based on Figure 2.1, all the possible cause was listed and branched until the factor cannot be subdivided anymore.

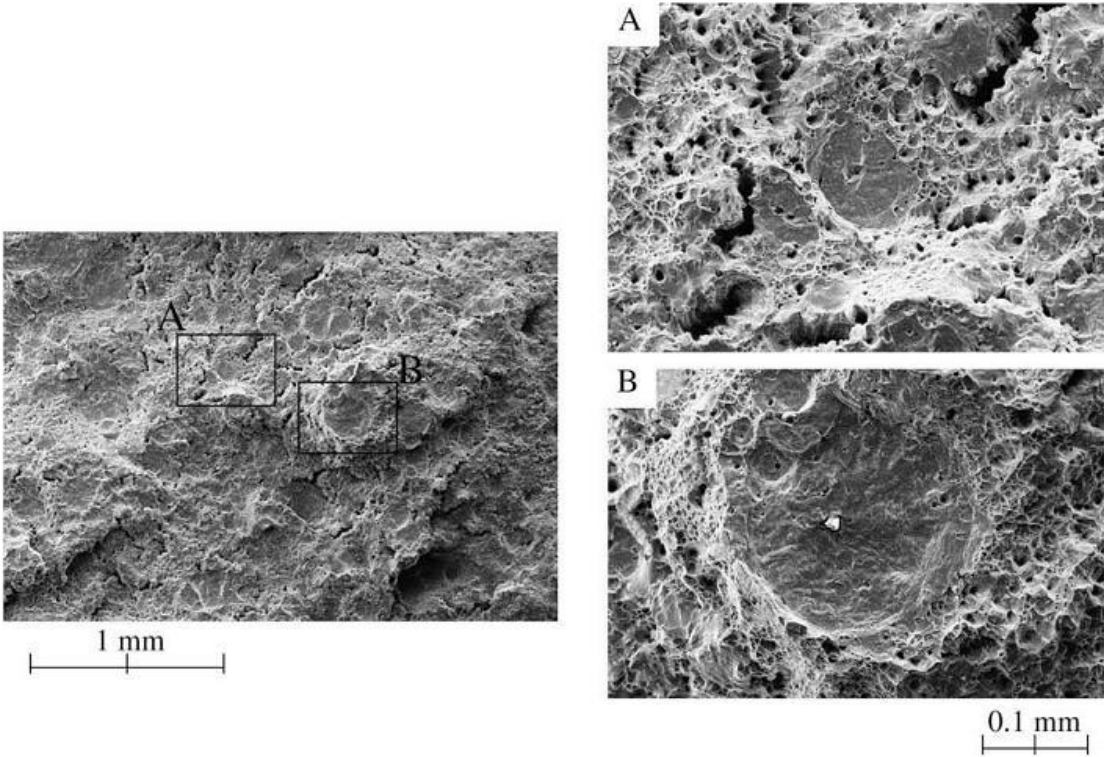
Figure 4.4: Fracture surface of sample material from journal. ^[3]

Figure 4.4 shows SEM observation images of a fractured surface. A relatively flat fracture surface was found near the origin of the internal cracks, while dimples due to ductile fracture were observed around them. The poor ductility may have caused the cleavage-like fracture surface inside the specimen. In the tensile test of the work hardened carbon steel, small cleavage cracks were initiated locally.

Compare to Figure 4.5 from the journal ^[3], the fracture surface from the stainless steel tubing is similar to that in the journal where the point of initiation takes place. The fracture surface around the point of initiation is brittle because of work hardening due to cyclic strain reduced the ductility of materials. Work hardening, also known as strain hardening, is the strengthening of a metal by plastic deformation. This strengthening occurs because of dislocation movements within the crystal structure of the material. ^[14]
