# CHAPTER 1

The failures of tubes in heat exchanger T-831 in Kerteh resulted carry unnecessary downtime to GPP Kerteh. The heat exchanger is shown in Figure 1. The tubes failure occurs approximately once every two years. Various opinions and suggestions have been given as the possible cause of failure. However a proper failure analysis study has not been performed. There were no study done to analyze the relations between the possible causes of problem, the exercised maintenance, and the implemented operation.

The objective of this project is to determine the causes of premature failures of heat exchanger tubes for Propane Refrigerant Condenser (T-831) in GPP Kerteh. This task consists of employing failure analysis methods in order to examine and investigate the possible causes of failure. Scope of work will include investigation of the material properties, review of regular operation parameter used, and inspection of maintenance activities conducted on the heat exchanger. It is anticipated that at the end of project, author will be provide suggestions in order to reduce the failures of the heat exchanger tubes.

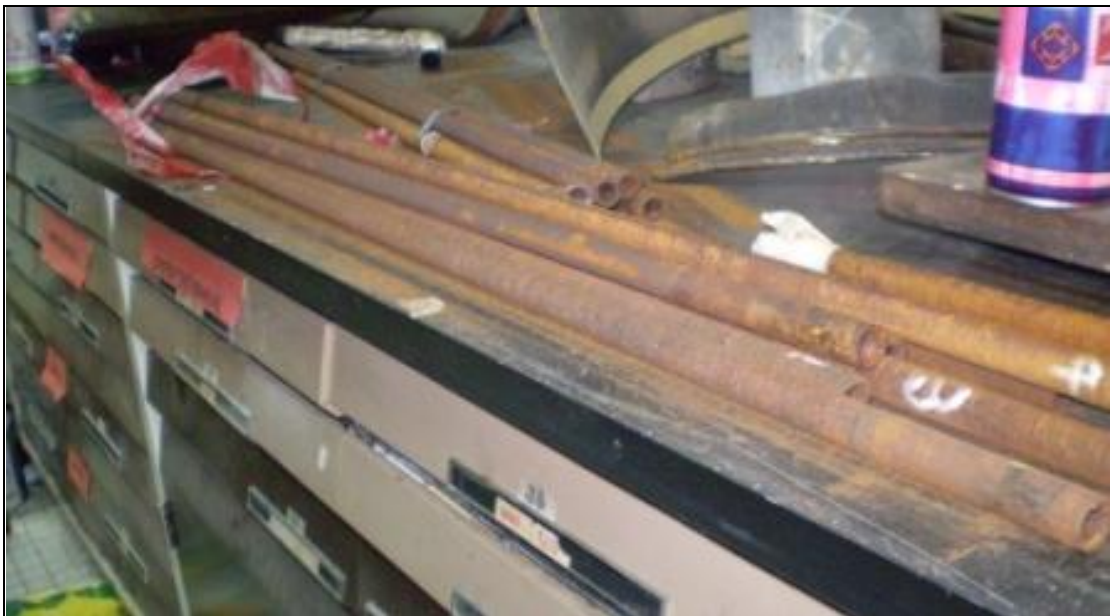
During the semester break of January 2008 semester, samples were obtained from GPP in Kerteh. Samples were stored in the Inspection Section office at GPP Kerteh. All the tubes were in highly corroded condition and two samples with white marking indicating failed regions were obtained. Author also performed snoop leak test on to the selected tubes, and no leakage was found. The two samples obtained are shown in Figure 14 and Figure 15.

Figure 13 : Tubes sample stored at Inspection Section, GPP Kerteh

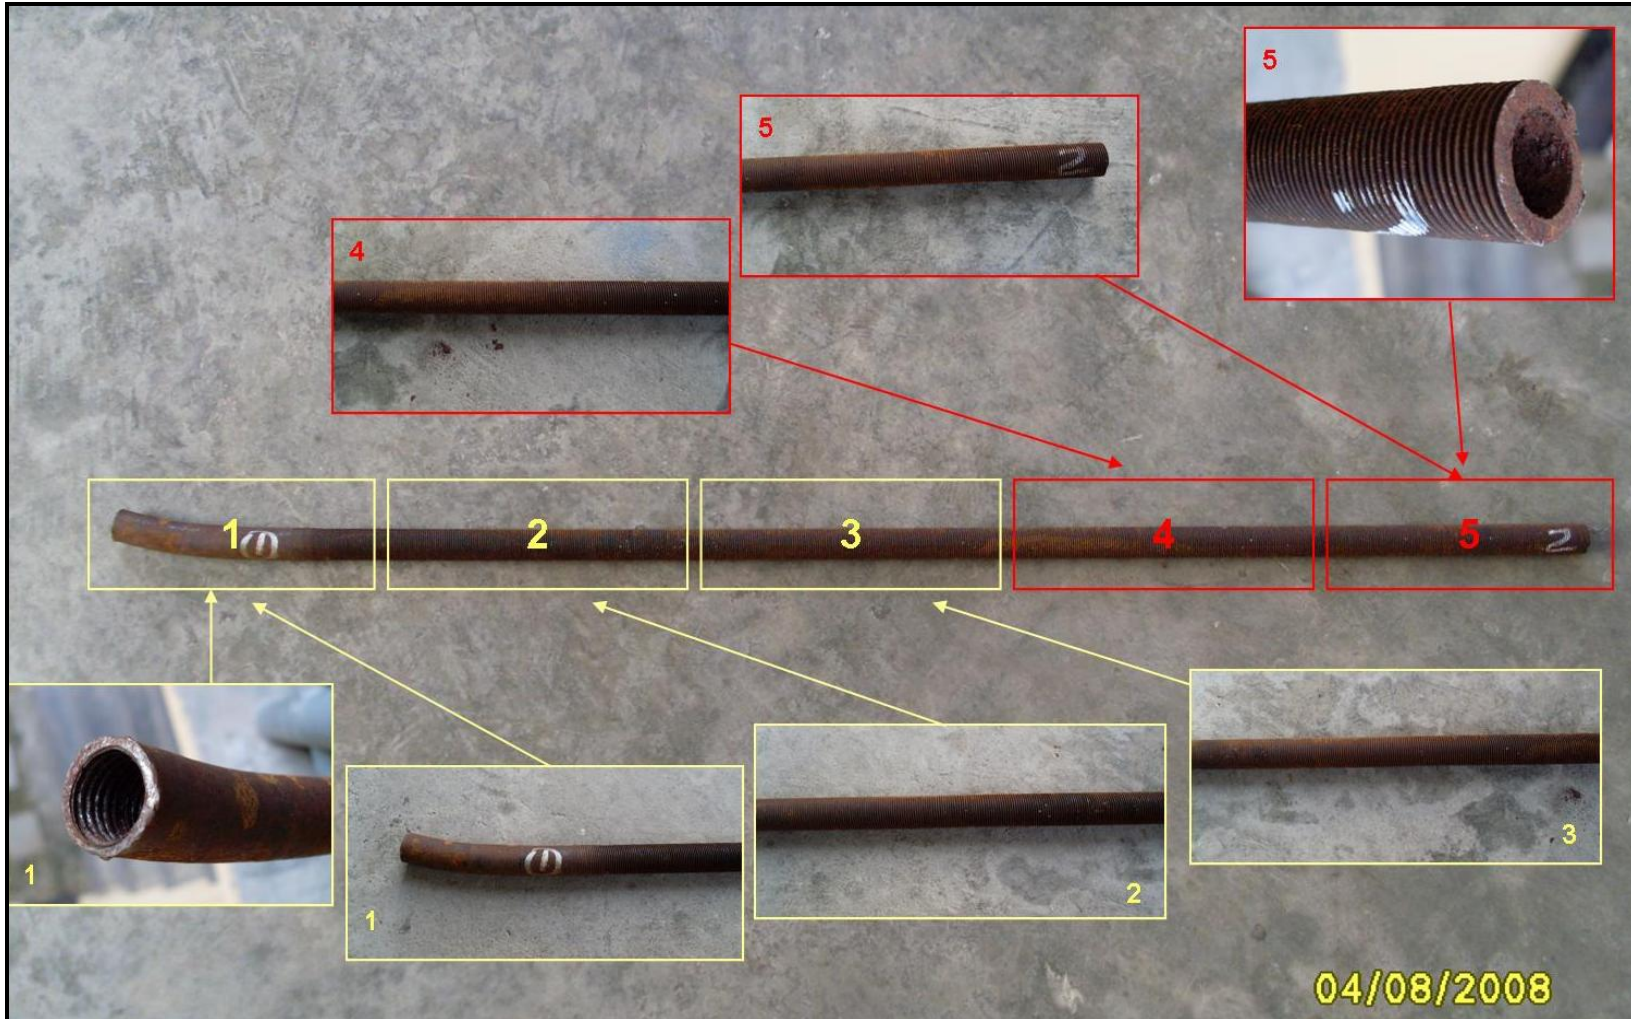
Figure 14 : Tube sample A

Before performing NDT, the samples were cut into shorter pieces and the rust on the surface were removed. Tube A was cut into five parts as shown previously in the Figure 12. Parts A-2 and A-4 were selected for NDE. Sample A-2 was selected because videoscope examination reveals excessive corrosion of the location. Sample A-4 show acceptable condition of the heat exchanger tubes.

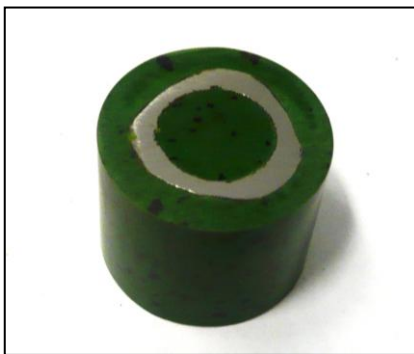
Figure 20: Mounted sample from tube A

- A crossed-section from tube A been taken.
- Green color mount used.
- Used in metallographic examination
- Been grinded, polished and etched.

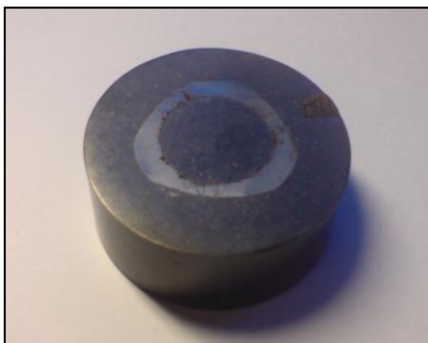
Figure 21: mounted sample of tube B

- Part of tube B
- Mounted in blank color mount.
- Tested as same as sample above.

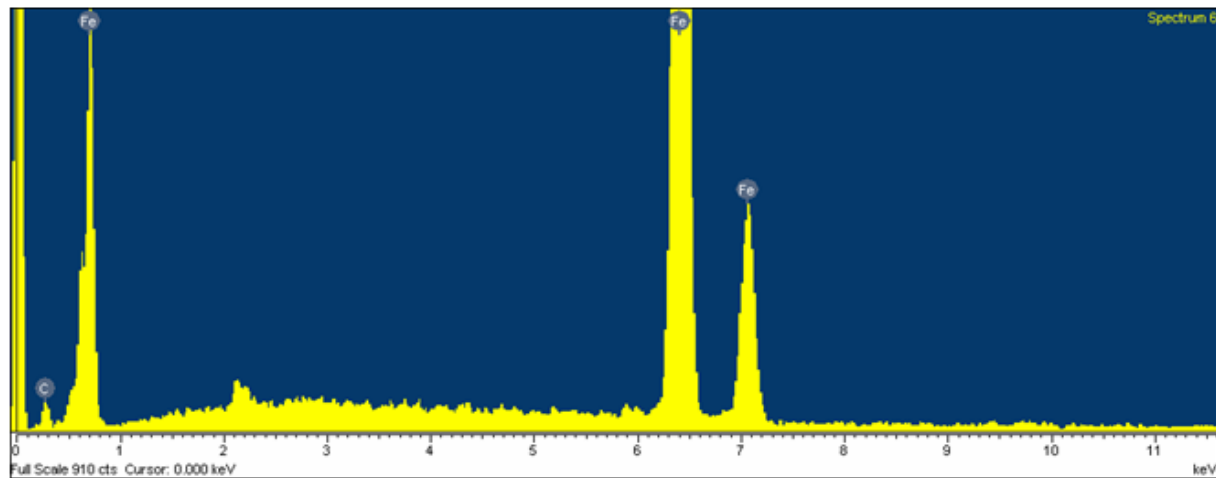
Energy Disperse Spectroscopy (EDS) in Figures 28 and 29 also revealed that there were presences of Cl in the elliptical pit, whereas the normal sample did not contain Cl.

- Shown that high attendance of Fe element.
- Carbon steel was used as the tubes material

Figure 28 : result of Sample B (approximately same as Sample A)
