Most of Carbon Steel tubing for Water Injection wells at Dulang Fields was badly corroded even though wells were completed with the new downhole tubing. In order to avoid or minimize the tubing internal corrosion problems, the study on microstructure of the tubing parts should be done especially on how to improve the material of the tubing.

The objective of the study is to determine the primary cause of a failure by investigating the corroded parts and to provide with the suggested improvement of suitable material for the downhole tubing. Also, to study on the microstructure of the Carbon Steel tubing i.e. whether the part has experience extreme heat, cold work, reveal crack and fatigue. The scope of the study covered on the analysis of material for Carbon Steel tubing by using optical microscope (OM) and scanning electron microscope (SEM) attached with

the energy dispersive x-ray spectroscopy (EDX/EDS). The determination of the failure was performed on well Dulang A-29L.

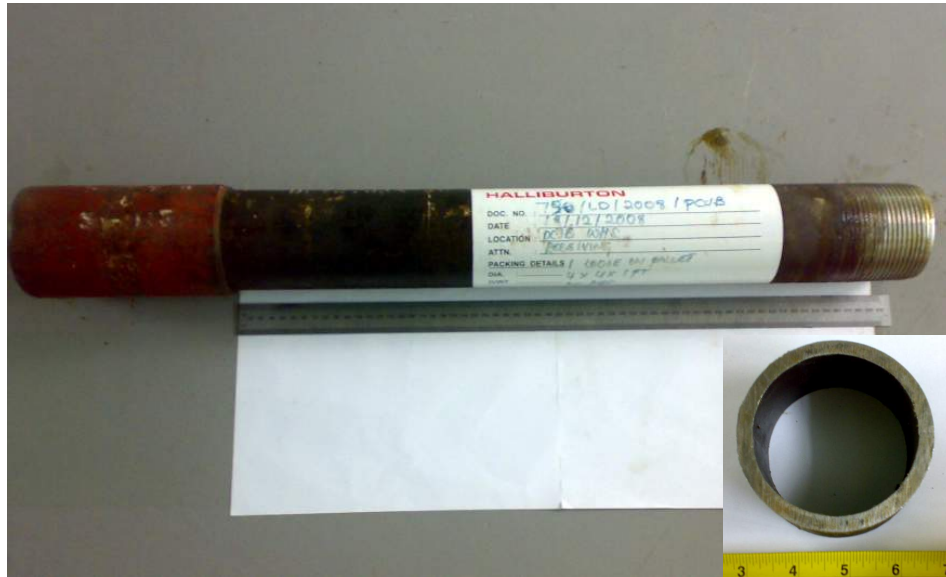
Figure 4.1: The grade L80 pipe of new steel tubular.

The Figure 4.1 shows the 2 ft length of new steel tubular product made by seamless process with 88.9 mm of outer diameter (OD) and 76.0 mm of inner diameter (ID) that was supplied by Halliburton Company for the use of typical water injection well. This steel tube with the grade of L80 pipe normally has been specified with the wall thickness of 12.7 mm [14].

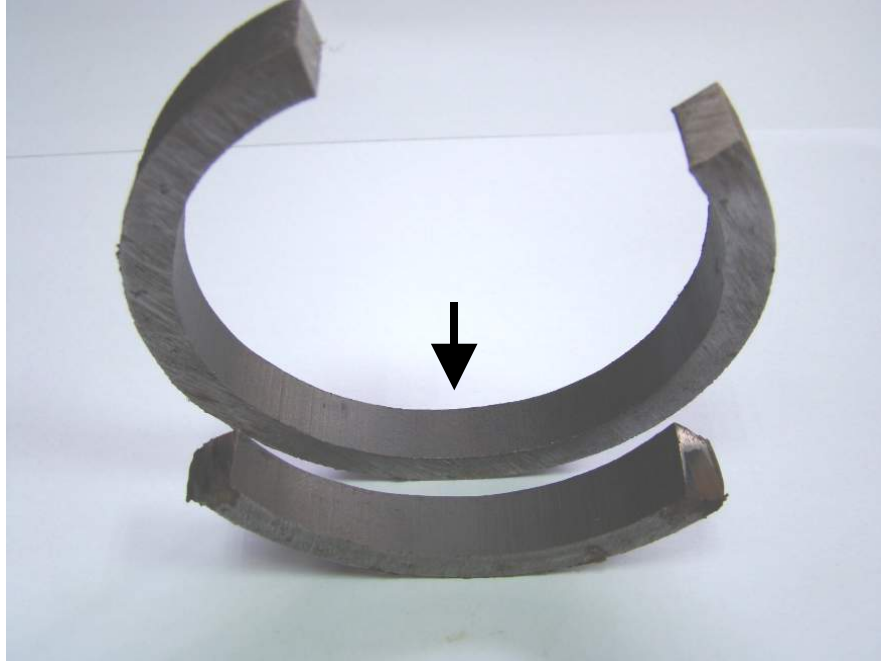
Figure 4.2: Photograph showing the internal surfaces of seamless tube.

Photographs of internal surfaces of the seamless tube were taken (see Figure 4.2). The arrow in Figure 4.2 shows the approximate location of Figure 4.3. The close-up examination on internal surfaces of tube as indicated in Figure 4.3 shows that there

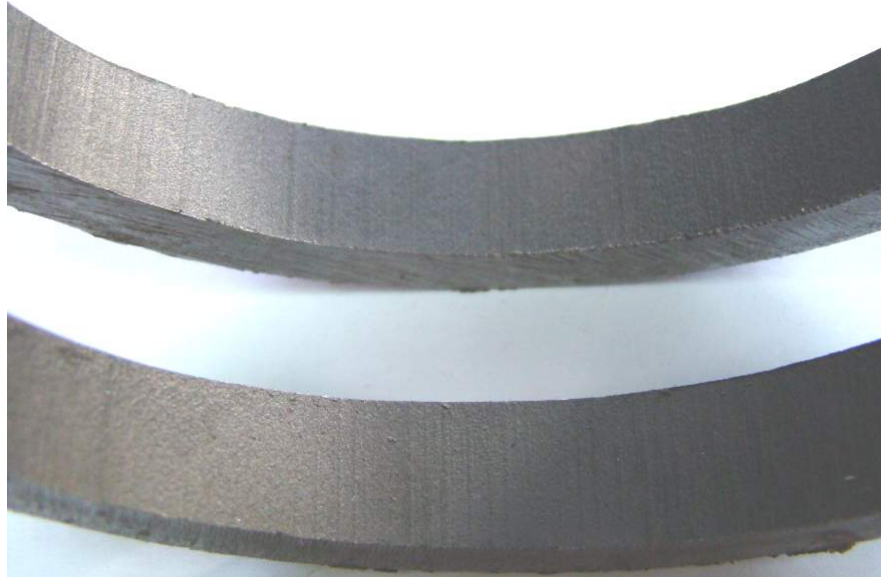
Figure 4.3: Close-up photograph on internal surfaces of seamless tube.

was no indication of seam/defects that has been introduced during the manufacturing process.

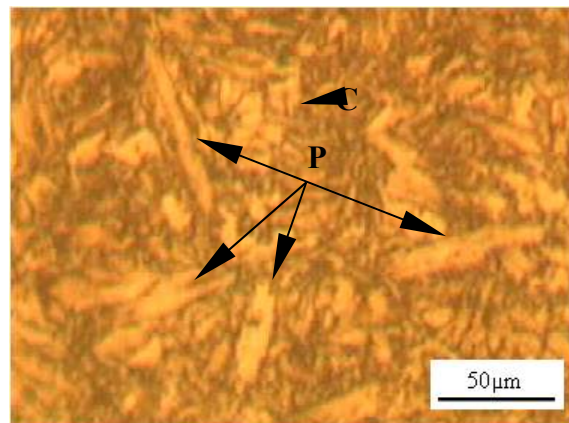
Figure 4.8: The optical micrograph of Fe-0.4C. 2% Nital etchant. Mag. 200x.

Transverse and longitudinal sections were taken respectively. These sections were metallographically prepared. The typical microstructure of the steel tubular was tempered martensite (see Figure 4.8) [9, 15]. The microstructure consists of ferrite and a few patches of tempered martensite. The present of plate martensites among the lath martensites are indicated by the region marked P (see Figure 4.8 and 4.9). The arrows marked C as in Figure 4.8 shows the formation of carbides precipitate, probably cementite particles with nital etched. The present of fine cementite was obtained due to high tempering temperature attained which was above 350°C during the heat treatment process. The detailed examination of the microstructure by scanning electron microscopy (SEM) confirmed that the microstructural feature developed for the steel tube was tempered martensite (see Figure 4.9).

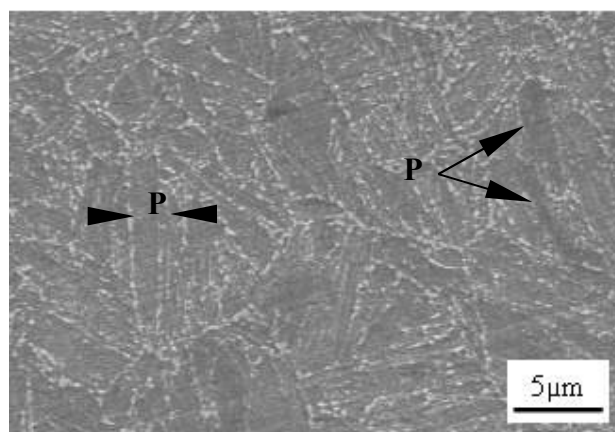
Figure 4.9: The scanning electron micrograph of Fe-0.4C. 2% Nital etchant. Mag. 2000x.

Detailed examination of the microstructure by scanning electron microscopy (SEM) shows the same features of tempered martensites found in the steel tube (see Figure 4.9 and 4.10). The region marked C as in Figure 4.11 and 4.12 indicated that the presence of carbides precipitate probably cementite at two different locations. In both areas, the microstructures features were dissimilar and not uniform throughout. The SEM shows that the fine cementite particles appear as far away from the hole area (see Figure 4.11). Besides, the abnormality confirmed by SEM as indicated by the region marked C as in Figure 4.12 which show that the spheroidized cementites appear towards the through wall hole. This was probably due to the excessive thermal exposure near the through wall holes area during the operation. Also, an arrow M indicates as a probable microcrack, an intragranular microcrack which runs transversely in regions of plate martensite. That arrow identified as a probable microcrack because the feature was aligned perpendicular to the direction of major arrays of cementite particles (regions marked C in Figure 4.11). This indication was probably due to cracking produced during quenching.
