Preventive Program for Small Bore Piping Failure At Gas Processing Plant

Dissertation submitted in partial fulfilment of
the requirements for the
Bachelor of Engineering (Hons)
(Mechanical Engineering)

JANUARY 2009

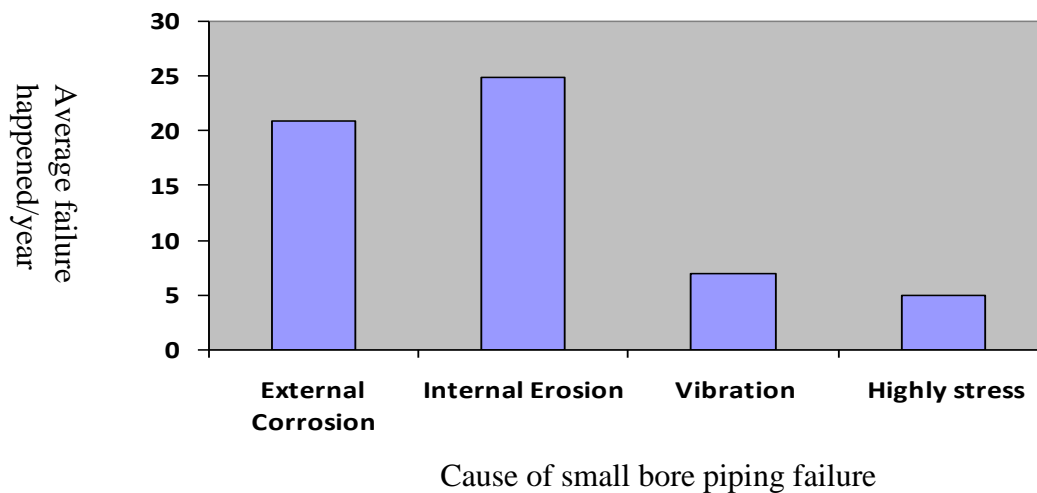
Figure 4.1: Average failure happened/year vs. cause of small bore piping failure

First of all, the author collect the data from PETRONAS Gas Berhad (PGB), Kerteh to get information about cause of small bore piping failure happened. The data was obtained from Inspection Department that responsible for any inspection task. From the data given, the author knows that internal erosion is the major cause for small bore piping failure.

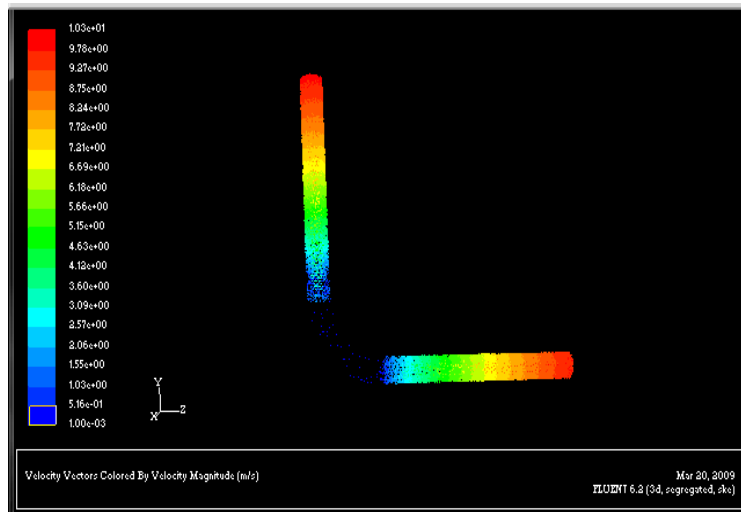
Figure 4.5: Fluent result for Velocity vector

By using FLUENT software, the result for Elbow Pipe was obtained (Figure 4.5). The author investigated the velocity of steam (water vapour) in the pipe first by setting velocity is 10m/s. From Fluent result, it shows that at inlet flow, the velocity is very high because it receives high pressure.

When the steam reach elbow, the velocity decrease because the steam collide elbow wall and need to change direction of flow. The elbow wall prevents the velocity of steam from running smoothly.

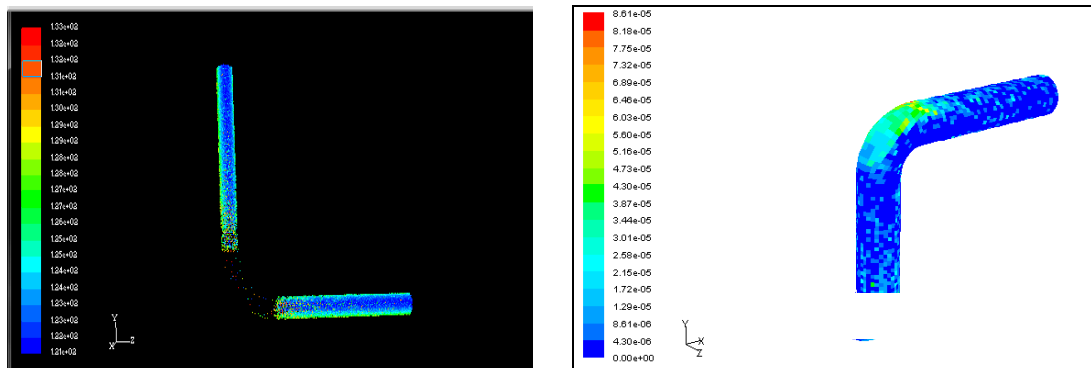
Figure 4.6: Fluent result for Pressure Developed

Secondly, the author investigated pressure developed in the elbow pipe design (Figure 4.6). From the result, the pressure is higher along the pipe wall and it increase when steam reach the elbow. The pressure is very highest at elbow pipe wall because the elbow prevent the steam from running smoothly and cause change of direction.

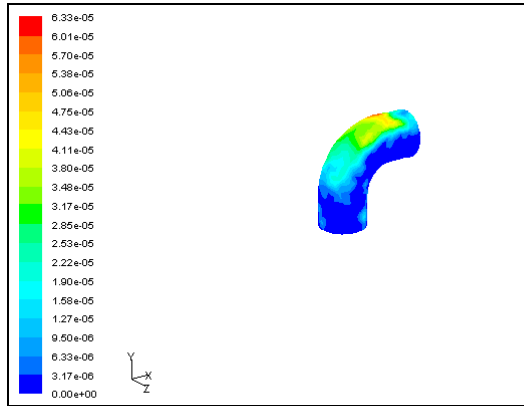
Figure 4.7: Fluent for Contour of erosion

The author focused on elbow pipe to get clear result for contour of erosion in steam line. The result (Figure 4.7) shows that the highest erosion effect obtained at outside elbow.

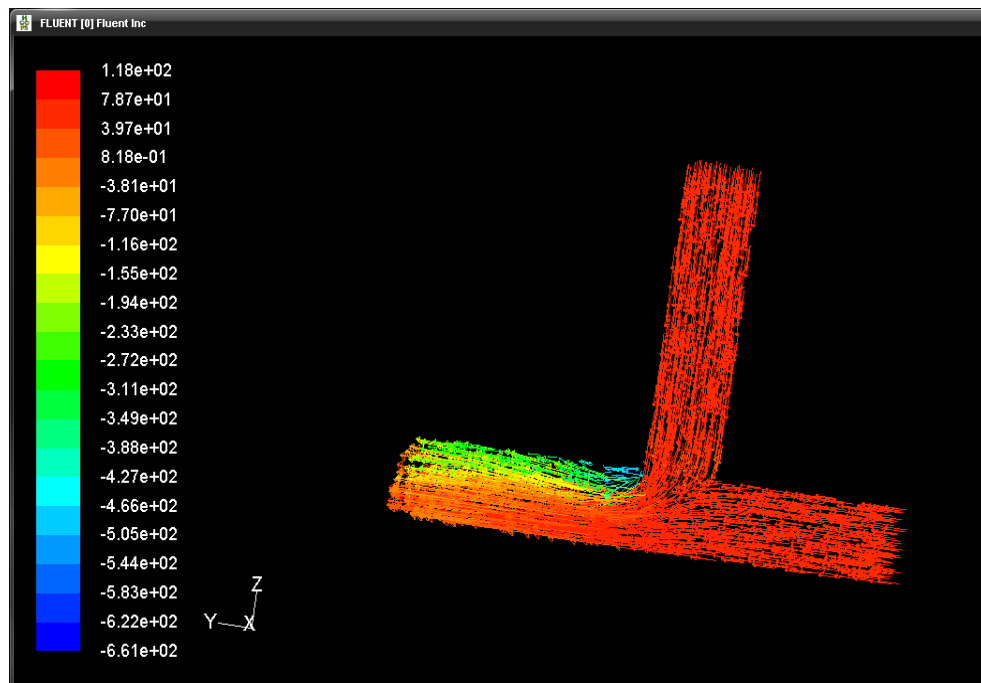
Figure 4.9: Fluent result for Velocity vector

By using FLUENT software, the result for Tee Pipe was obtained. The author investigated the velocity of steam (water vapour) in the pipe first by setting velocity is 10m/s. From Fluent result (Figure 4.9), it shows that at inlet flow, the velocity is very high because it receives high pressure. When the steam reach tee joint, the velocity decrease because the steam collide tee joint wall and need to change direction of flow. The tee joint wall prevents the velocity of steam from running smoothly.

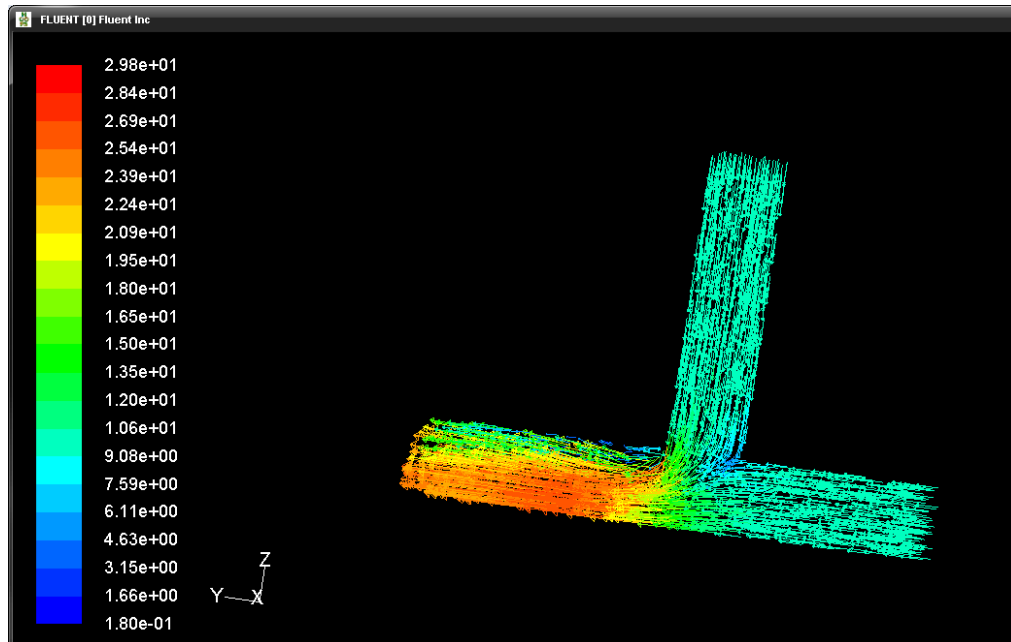
Figure 4.10: Fluent result for Pressure Developed

Secondly, the author investigated pressure developed in the tee pipe design. From the FLUENT result (Figure 4.10), the pressure is higher along the pipe wall and it increase when steam reach the tee joint. The pressure is very highest at tee joint pipe wall because the tee joint prevent the steam from running smoothly and cause change of direction.
