Failure Investigation of a Steel Pipe

**A project dissertation submitted to the
Mechanical Engineering Programme
Universiti Teknologi PETRONAS
in partial fulfilment of the requirement for the
BACHELOR OF ENGINEERING (Hons)
(MECHANICAL ENGINEERING)**

July 2008

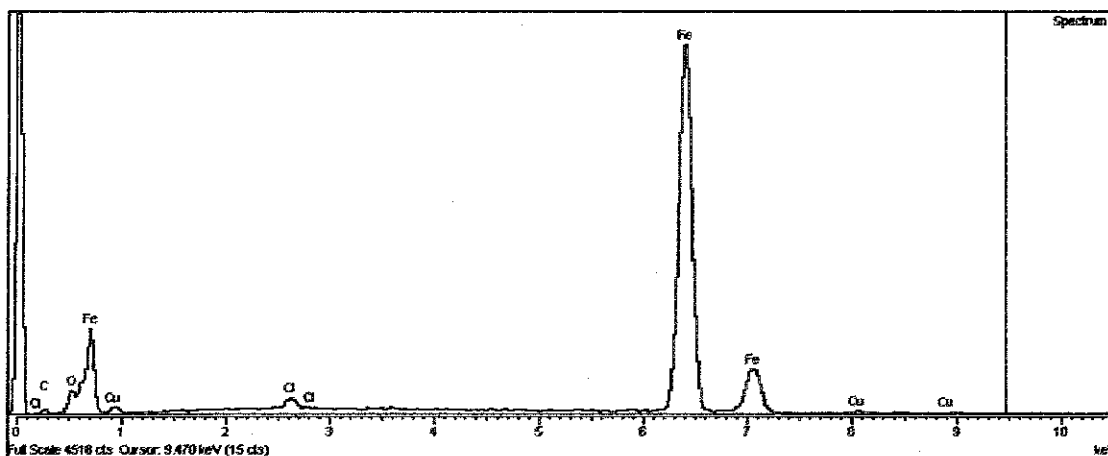
Figure 4.15: The element distribution along the normal pipe sample.

Different EDS examination is taken from pipe sample that far away from failure location and the result is as in Figure 4.15 and Table 4.2. The graph and table show that the percentage of Fe element is high compare to previous data. The oxygen element percentage is very low. These qualitative results indicate that the sample is still in good condition.
