Failure Analysis of Heat Exchanger's Tubes at GPP Kerteh

Dissertation report submitted in partial fulfilment of
the requirements for the
Bachelor of Engineering (Hons)
(Mechanical Engineering)

JULY 2008

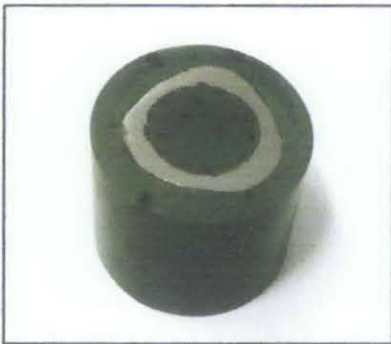
Figure 20: Mounted sample from tube A

- A crossed-section from tube A been taken.
- Green color mount used.
- Used in metallographic examination
- Been grinded, polished and etched.

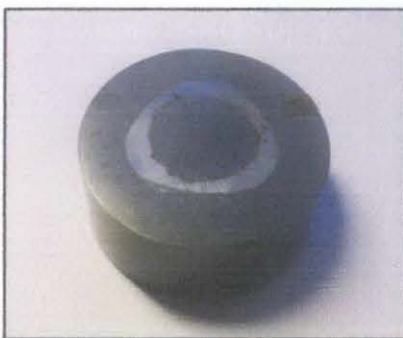
Figure 21: mounted sample of tube B

- Part of tube B
- Mounted in blank color mount.
- Tested as same as sample above.
