# **Impact Resistance of Polyurea Coating**

Bachelor of Engineering (Hons.)

(Mechanical Engineering)

Universiti Teknologi PETRONAS

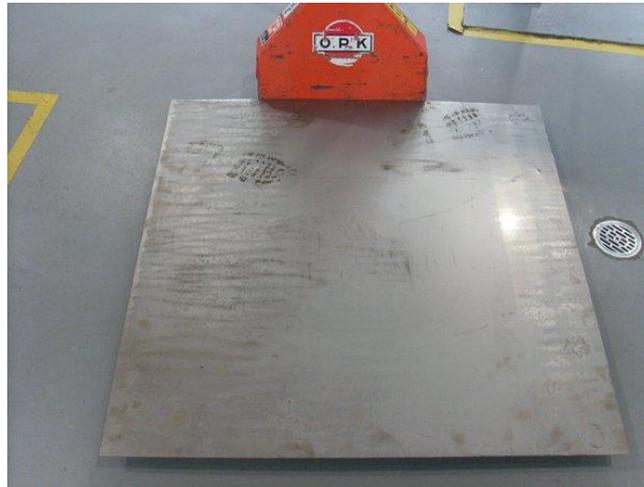
**Figure 2:** Example of 0.45mm cold rolled mild steel

Example of cold rolled mild steel specimen is shown in Figure 2 below.

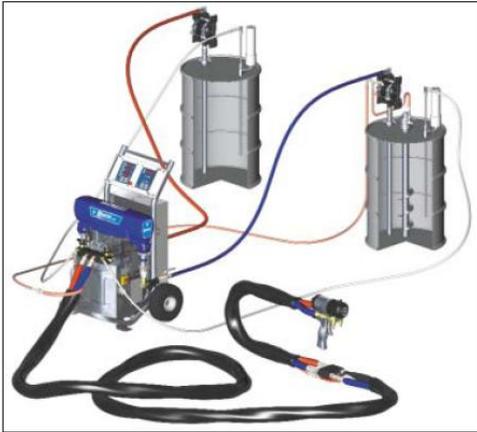
**Figure 3:** High pressure coating application equipment[2]

No allowances have been made for material waste, uneven surfaces, spillage, material applied thicker than specified, or material left in containers or equipment [2]. The equipments used for coating application are described in Figure 3 and 4.

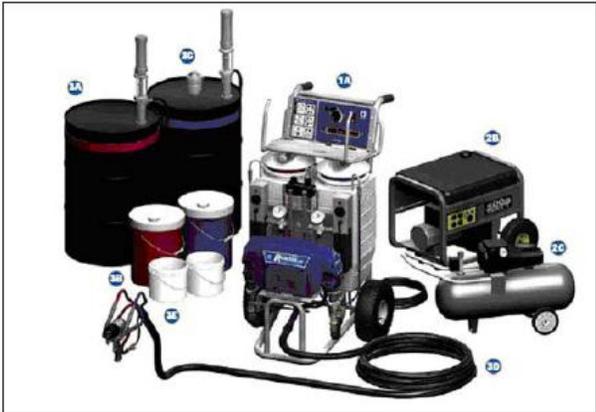
**Figure 4:** Low Pressure coating application equipment[2]

Formulations that require minimal applications pressure does not require added heat allow for the use of fewer complexes and less expensive equipment in the application process. These formulations typically exhibit slightly reduced physical properties than the high pressure formulations, but still maintain much higher physicals than traditional and create a wider range of contractors worldwide that are capable of applying the products correctly.

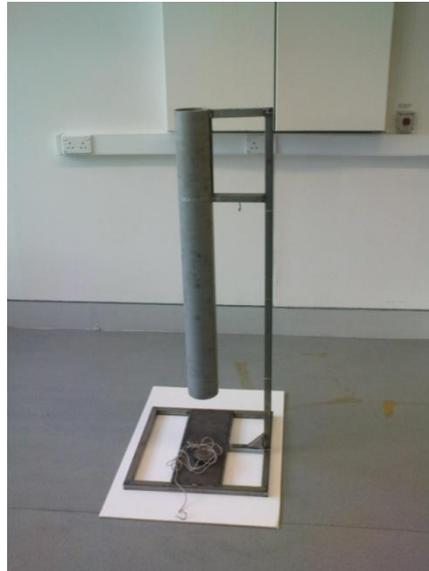
**Figure 7:** Impact tester

The whole impact testing machine is called tester. The base is called the panel support which the specimen lays, and the pipes act as a guide tube. A guide tube functions to guide the impact so that it will strike the specimen precisely. The machine was designed so that it can withstand the capacity of impact up to 100J and its total height is 1.35 meter.

Figure 7 below describes the impact testing rig.

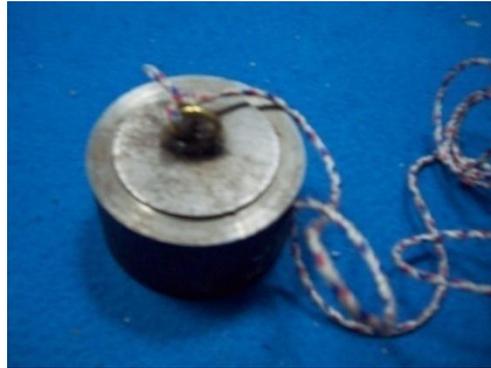
A weight, or drop weight is a cylindrical weight that was used to be dropped on the specimen. The weight was held stationary and was release as to strike an indenter

**Figure 8:** The impactor.

which was laid on top of the specimen. The weight of the impactor varies depending on requirement of the test. Figure 8 below describes the impactor.

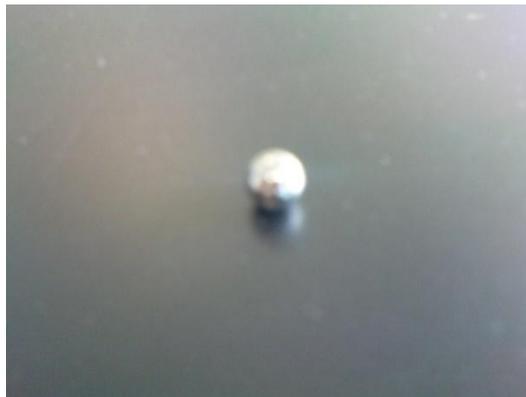
Indenter, or punch, is a steel metal punch with a hemispherical head having a diameter of 7.9mm. The punch laid on the coating panel as the weight is dropped. Figure 9 below describes the indenter.

**Figure 9:** The indenter

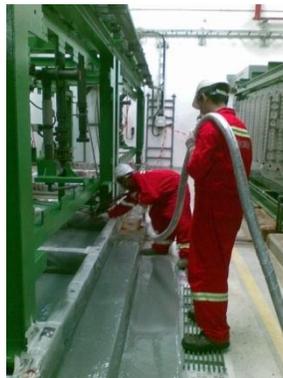
**Figure 13:** Example of the polyurea coating is being applied by industrial expert of Dyna

The equipment that was used for coating will as mentioned in chapter 1, which is the high pressure coating application equipment and it was owned by Segmen Sdn Bhd. Figure 13 shows how polyurea coating being applied in industry.

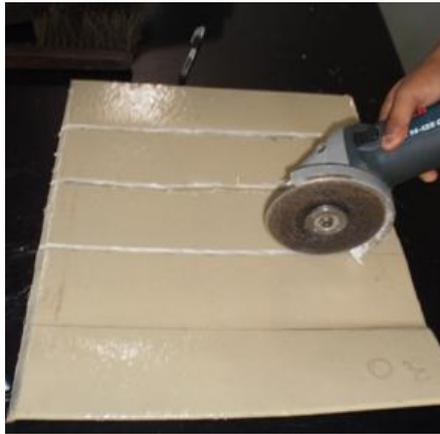
**Figure 14:** 1m x 1m polyurea coating was undergoing the cutting process.

The main purpose of the grinding was to lower the thickness of the coating at certain area so that the coating can be cut easily. After the cutting process was done, the sample was packaged and labeled to differentiate and group each other in their own group of thickness.

Figure below shows the coated 1m x 1m specimen which undergoes the cutting process.

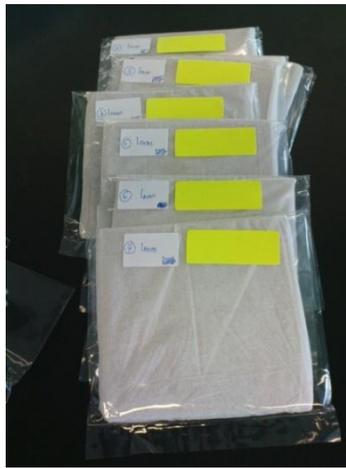
**Figure 15:** Group A1, 1mm thickness specimens after the large coated specimens being cut, packaged and labeled. This process was repeated for other groups of thickness as well, namely group A2, A3, and A4.

The samples of the coated specimens being cut into 100mm x 100mm, labeled and grouped are shown in figure 15 below.

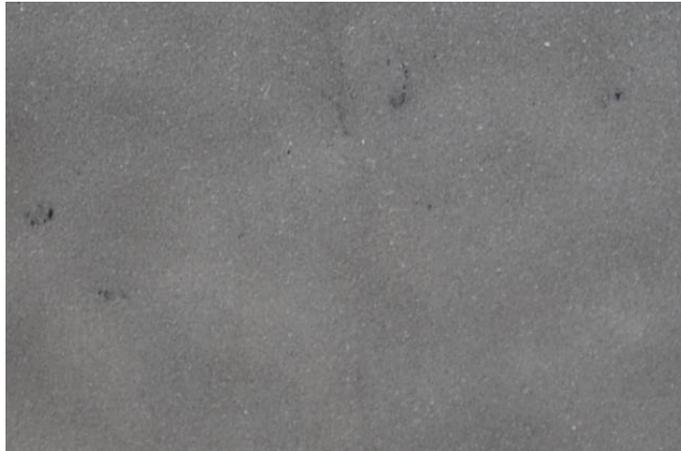
**Figure 19:** Specimen 1/1mm after being impacted with 3.15 J

It was observed that no indentation occurred and the coating had passed. Table 3 below summarizes the results for impact testing on this specimen

Figure 19 describes the results for specimen no 1 /1mm.

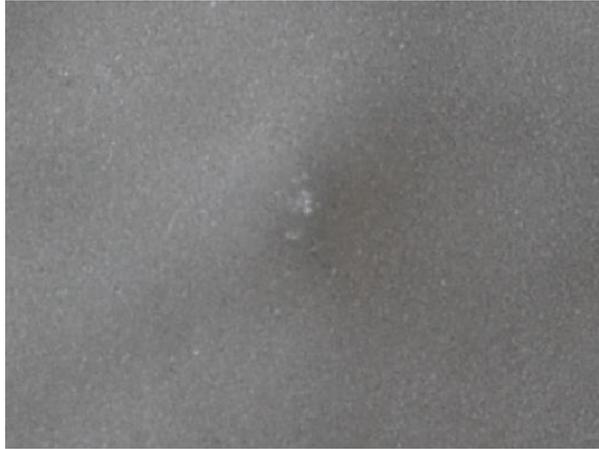
**Figure 20:** Specimen 7/1mm after being impacted with 23.02 J. Very minor crack observed.

Indentation was observed at the impacted area. No sign of cracking observed.

Figure 20 below describes the results for specimen no 7 /1mm.

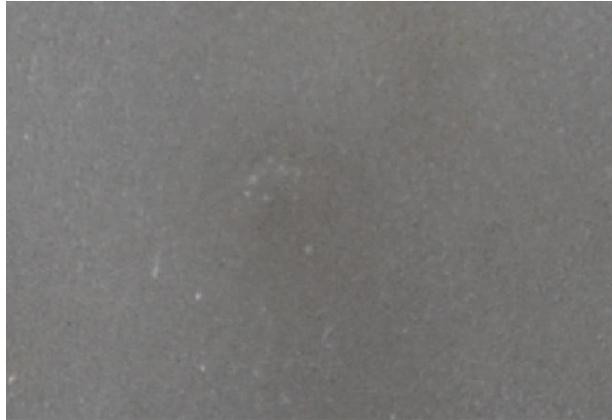
**Figure 21:** Specimen 3/1mm after being impacted with 25.01J Notice the slight indentation.

For this specimen, indentation can be seen at the impacted area. The slight crack signs were there. Table 5 summarizes the results for impact testing on this specimen

Figure 21 describes the results for specimen no 3 /1mm.

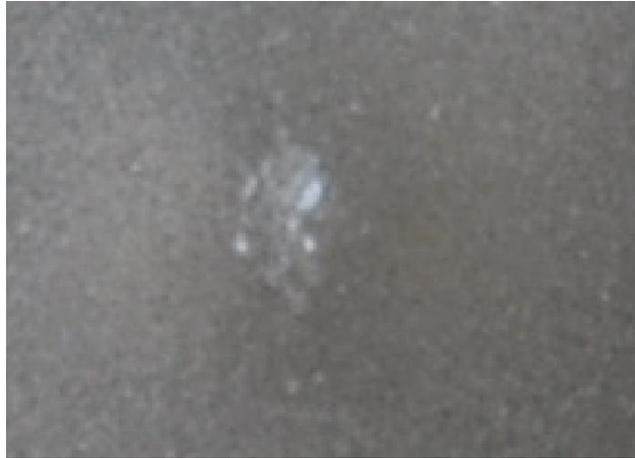
**Figure 22:** Specimen 4/1mm after being impacted with 31.09 J. Crack observed.

Indentation noted on the surface. The steel plates are damaged due to the impact forces. Cracking sign observed at the center of the impacted surface. The coating failed. Table 6 below summarizes the results for impact testing on this specimen

Figure 22 describes the results for specimen no 4 /1mm.

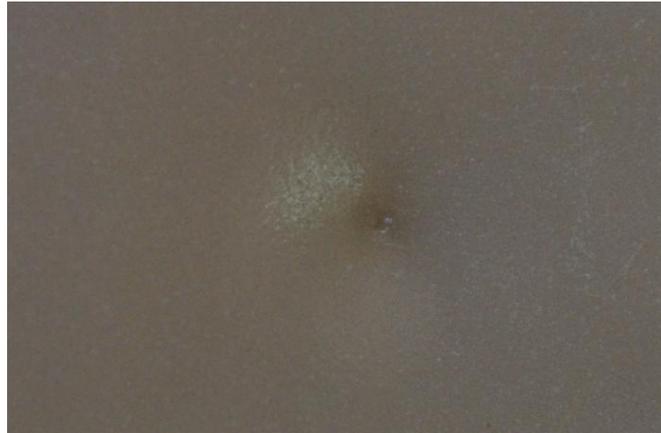
**Figure 23:** Specimen 3/1.5mm after being impacted with 25.30 J.

Indentation was noted, but the cracks sign was not there. The coating passed the test. Table 7 below summarizes the results for impact testing on this specimen.

Figure 23 describes the results for specimen no 3 /1.5mm.

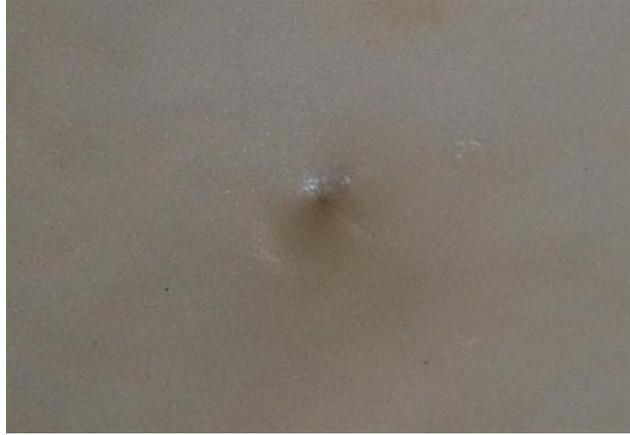
**Figure 24:** Specimen 4/1.5mm after being impacted with 31.62 J.

Deeper indentation was noted, 0.87mm, but the cracks sign was not there. The coating passed the test. Table 8 below summarizes the results for impact testing on this specimen.

Figure 24 describes the results for specimen no 4 /1.5mm.

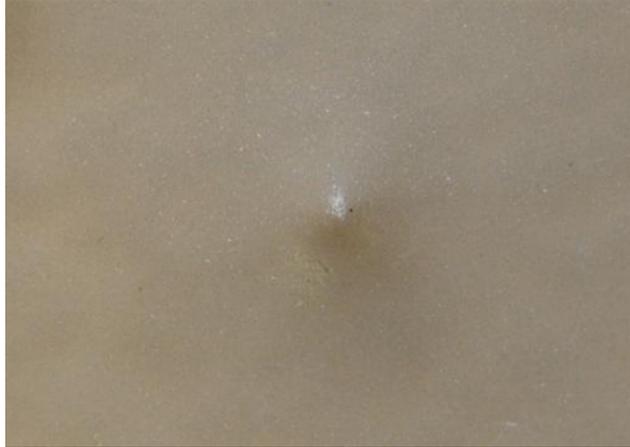
**Figure 25:** Specimen 1/1.5mm after being impacted with 45.76 J.

From the figure above it can be seen that indentation, much deeper than specimen 2 was noted, but the cracks sign was not there. The coating passed the test. Table 9 summarizes the results for impact testing on this specimen.

Figure 25 describes the results for specimen no 1 /1.5mm.

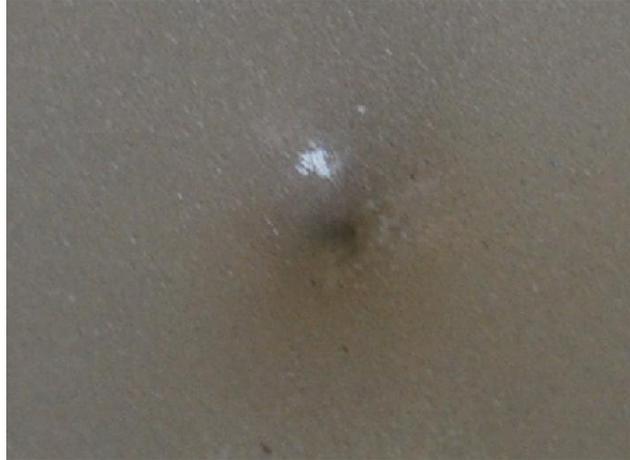
**Figure 26:** Specimen 5/1.5mm after being impacted with 49.80 J.

Slight crack signs are visible at the center of the impacted area. The coating failed. Impact depth is about 1.31 mm depth. Table 10 below summarizes the results for impact testing on this specimen

Figure 26 below describes the results for specimen no 5 /1.5mm.

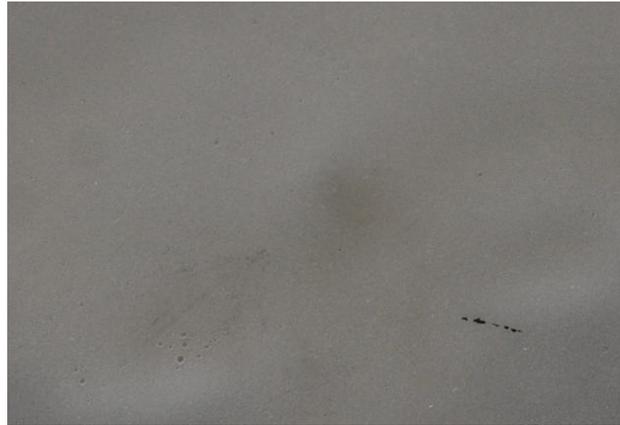
**Figure 27:** Specimen 4/2mm after being impacted with 31.09 J.

For this specimen, a very minor indentation can be seen at the impacted area. No signs of cracking observed. It was important to note that 1mm coating failed at this 31.09 J impact force whilst the 2mm coating did not. Table 11 below summarizes the results for impact testing on this specimen

Figure 27 below describes the results for specimen no 4 /2mm.

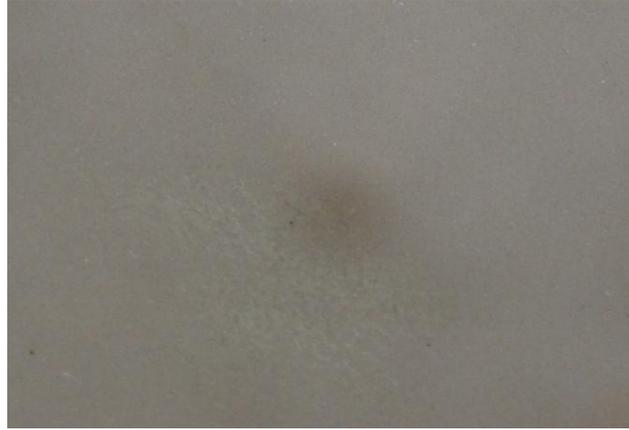
**Figure 28:** Specimen 5/2mm after being impacted with 37.96 J.

Indentation was noted, but with no crack signs. Table 12 summarizes the results for impact testing on this specimen.

Figure 28 describes the results for specimen no 5 /2mm.

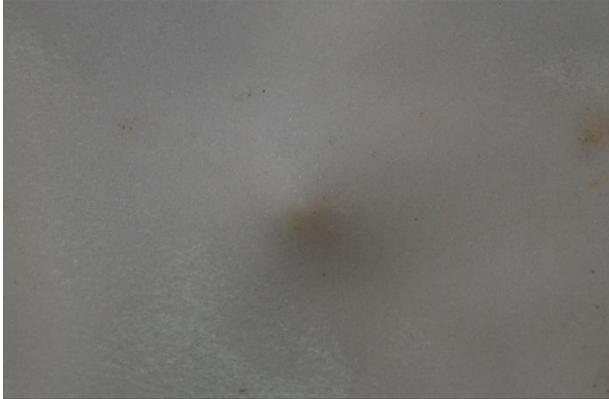
### 4.5.3 Specimen no 6/2mm

Figure 29 describes the results for specimen no 6 /2mm.

**Figure 29:** Specimen 6/2mm after being impacted with 51.24 J.

Deeper indentation was noted, but with no visible crack signs. The coating still passes the test. Table 13 below summarizes the results for impact testing on this specimen.

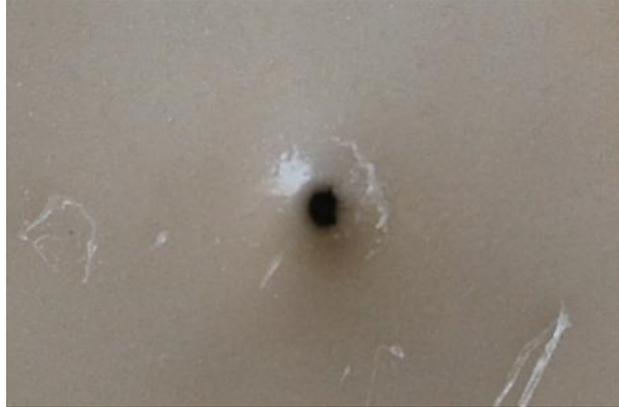
#### 4.5.4 Specimen no 7/2mm

Figure 30 describes the results for specimen no 7 /2mm.

**Figure 30:** Specimen 7/2mm after being impacted with 65.28 J.

The specimen failed catastrophically. Coating at the impacted area was tear from the substrate, and the impact force was high enough for the punch to make hole at the coating. The coating failed. Table 14 below summarizes the results for impact testing on this specimen.

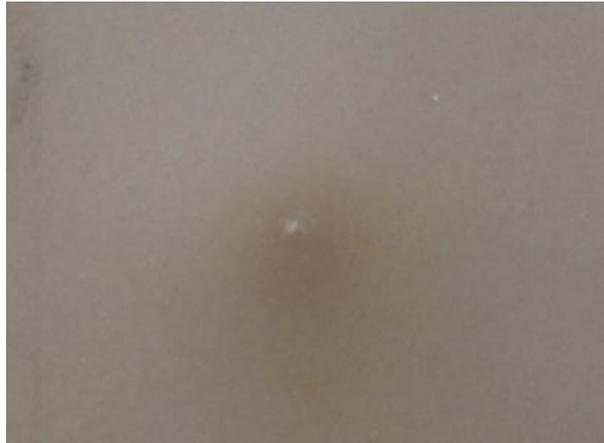
### 4.6.1 Specimen no 1/2.5mm

**Figure 31:** Specimen 1/2.5mm after being impacted with 44.28 J.

Indentation was noted, but with no visible crack signs. The coating passed the test. Table 15 below summarizes the results for impact testing on this specimen.

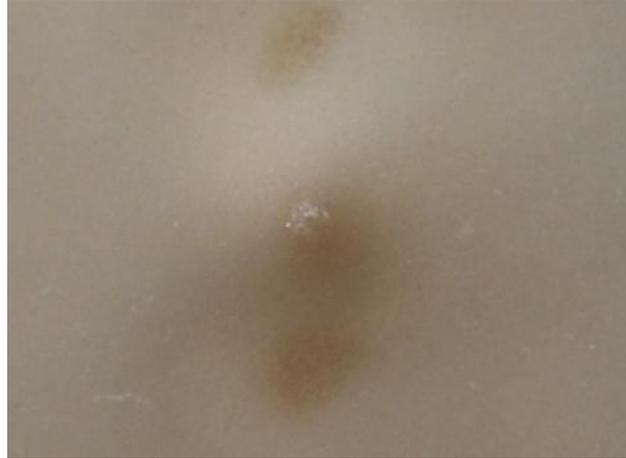
#### 4.6.2 Specimen no 3/2.5mm

Figure 32 describes the results for specimen no 3 /2.5mm.

**Figure 32:** Specimen 3/2.5mm after being impacted with 62.61 J.

For this specimen it was observed that there was a deeper indentation, with 1.87mm depth, but with no visible crack signs. The coating passes the test. Table 16 summarizes the results for impact testing on this specimen.

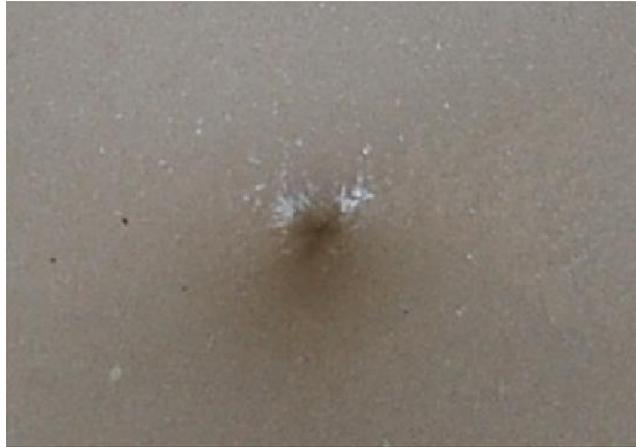
### 4.6.3 Specimen no 4/2.5mm

Figure 33 below describes the results for specimen no 4 /2.5mm.

**Figure 33:** Specimen 4/2.5mm after being impacted with 72.71 J.

A deep indentation spotted, with 2.1mm depth. There was a very minor sign of cracking at the center of the specimen but not that observable. The coating passes the test. The coating passes the test. Table 17 summarizes the results for impact testing on this specimen.

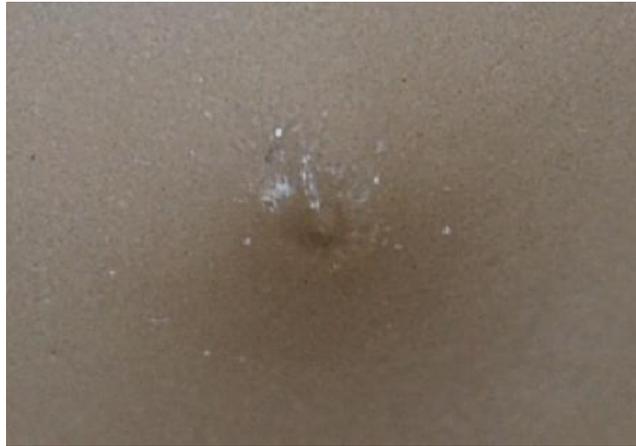
#### 4.6.4 Specimen no 5/2.5mm

Figure 34 describes the results for specimen no 5 /2.5mm.

**Figure 34:** Specimen 5/2.5mm after being impacted with 82.22 J

The specimen failed. Similar observation was noted; with the base of the coating at the impacted area tear from the substrate. Crack signs observed at the impacted area. The coating failed. Table 18 below summarizes the results for impact testing on this specimen.
